Field Reports

POINT NEPEAN QUARANTINE STATION TRAMWAY

Q STATION (formerly Manly Quarantine Station) and its light railway
(LR 198)

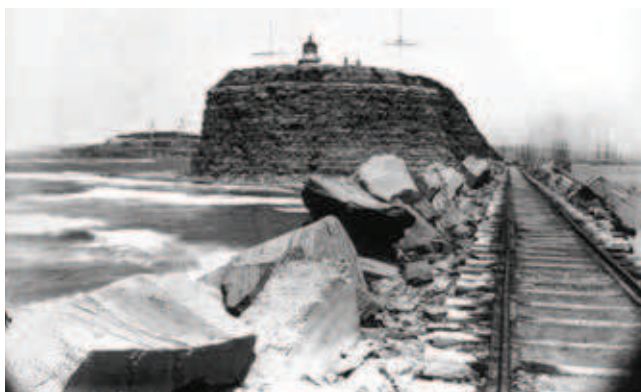
The attached photo (below) may be of interest. It shows the track on Nobbys Breakwater at Newcastle when it was operated by the NSW Department Public Works. The date is uncertain, and indeed I am unsure if the rails are indeed Barlow or a form of large bridge rails.

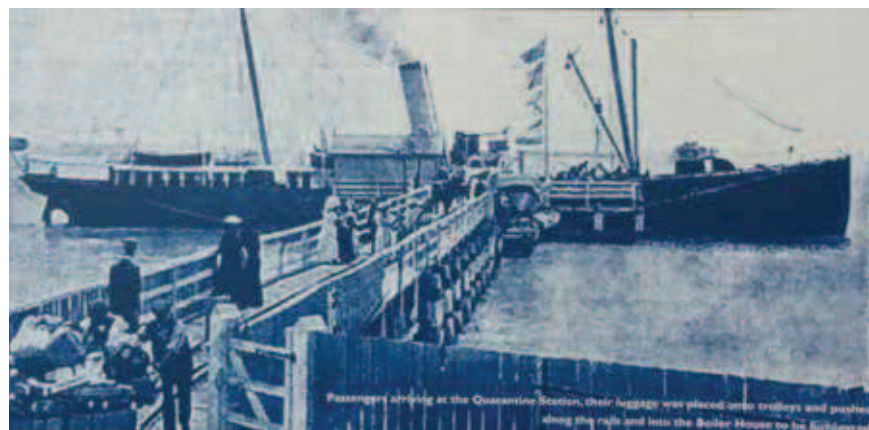
An early view of Port Nepean jetty, on the historical information board. Photo: Nepean Historic Society

The remaining rail system described is all set in concrete – a little hard to scrap! The photo below clearly shows men pushing a loaded trolley through a reverse curve at the end of the jetty, diverging to the eastern (leeward) side of the passenger waiting room.

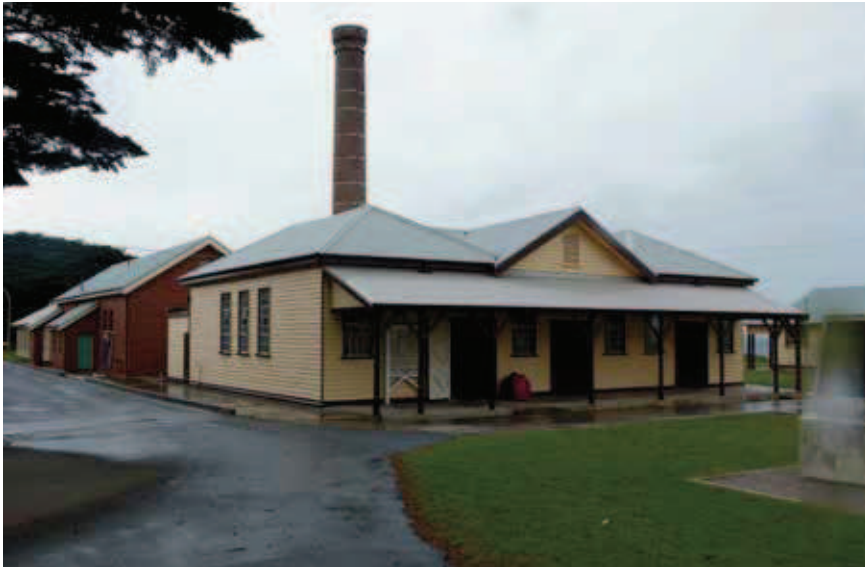
The main buildings, with the foul luggage store in the foreground

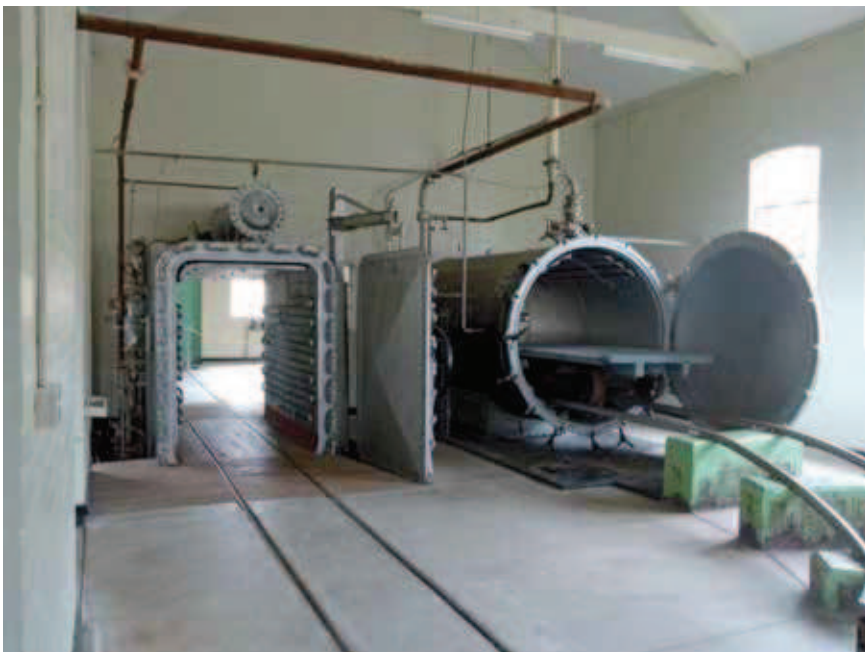
The two autoclaves. A small wooden-framed trolley sits inside the circular unit Photo: Andrew Forbes

The display as set up shows the wooden trolleys being used in the autoclave. This could not have been the case, as at 180 degrees C the wooden frames would not last very long, not to mention the impregnation of formaldehyde!

I believe that the gallery area in front of the two autoclaves was a sorting and loading area onto the special all-steel trolleys; a low trolley to suit the circular autoclave and a large rivetted box shaped unit to suit the newer French autoclave.

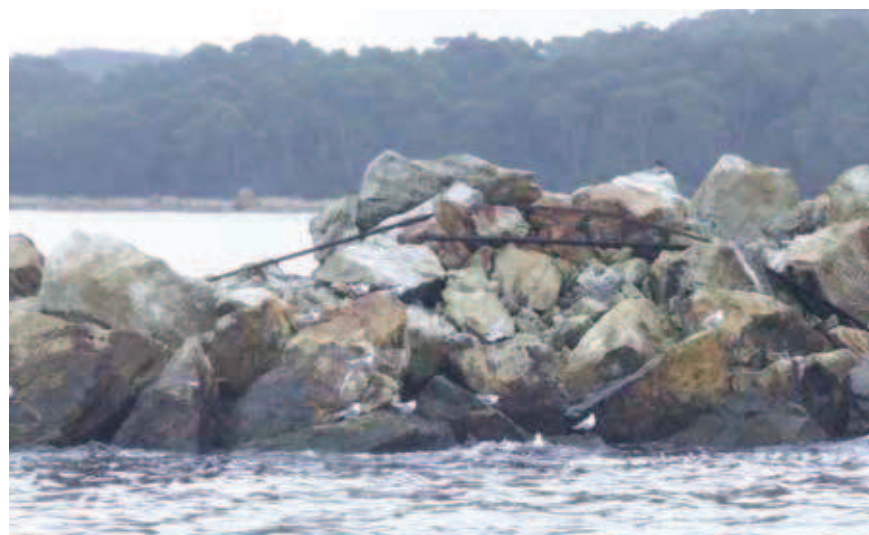
Hells Gates breakwater, showing the remains of the construction railway

While holidaying in Tasmania, we went on a boat cruise around Macquarie Harbour at Strahan and from the boat it was possible to see some of the old light railway tracks rusting away on the breakwater at Hells Gates, which is the entrance of Macquarie Harbour. The breakwater was built during 1900 and 1901 as part of the dredging of the shallow entrance. It was made by backing a narrow gauge train along its length which tipped its load of rocks into the channel with more rails being added as the breakwater increased in length. The channel was dredged so that large vessels could anchor at Strahan to pick up timber which was logged in the area. There is a legend

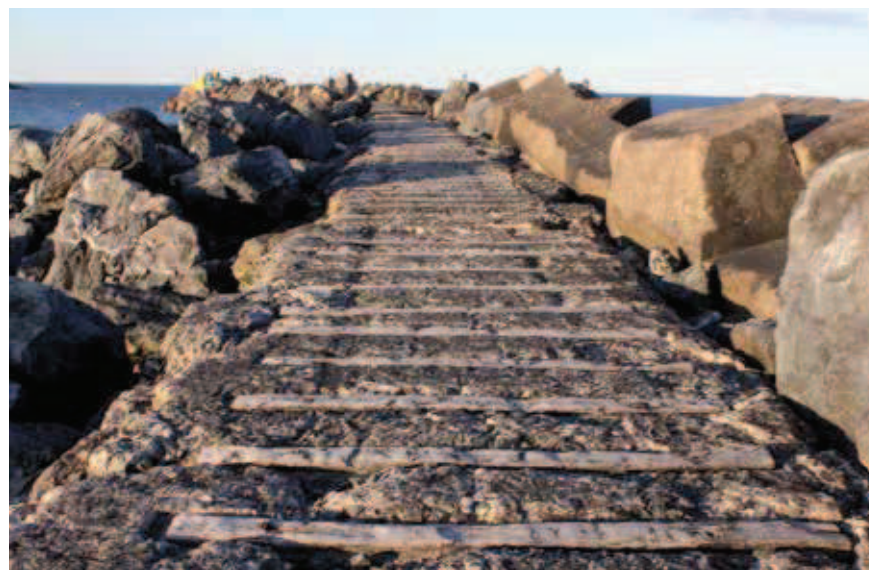
*The remains of the Coffs Harbour breakwater tramway, last used in 1974 and soon to be covered forever as reconstruction works raise the wall level, seen on 25 August 2012
Photo: Ken Littlefair*

A recent visit to the Coffs Harbour breakwater revealed some remaining rails and the imprint of the sleepers as well as a deviation (possibly points) where the rail line ran from the quarry (and other points west I believe) out to the end of the southern breakwater.

The sleeper imprints can be seen most of the way to the end of the breakwater, and in many places

the sleepers still exist. However, the sea is playing havoc with the remaining portions, particularly where the waves break over the breakwater and are dislodging the rocks and embankment. From the concrete elements stacked in the nearby quarry, it appears that some remedial work is about to commence which may wipe out many traces of the old line. (A two-year project to raise and reinforce the breakwater is scheduled to commence this year, and will bury the remains of the tramway by 800mm – Editor.)

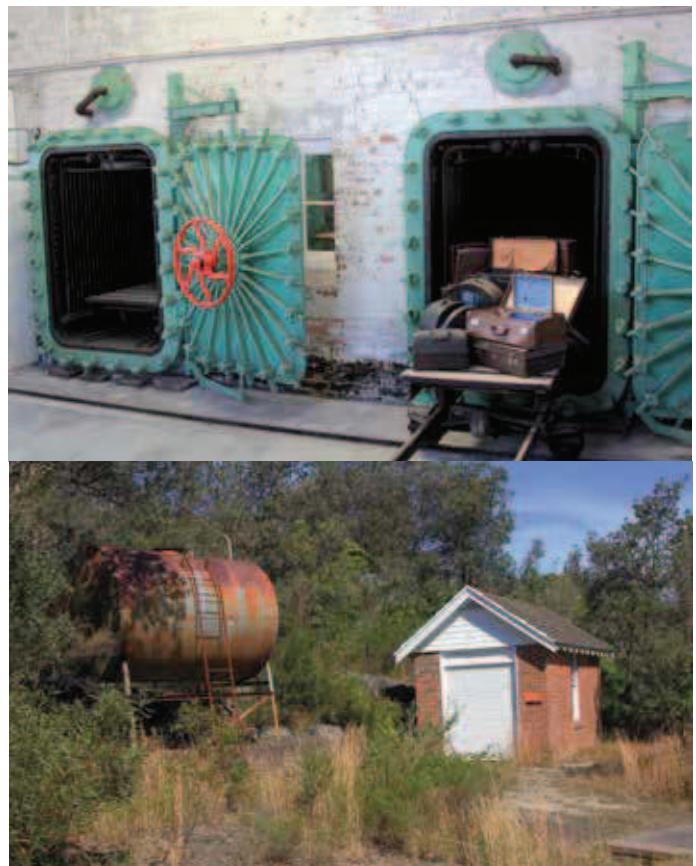
Clockwise from above left: Sketch map, by Jim Longworth, of the light railway at Manly Quarantine Station (first published in LR 198). • The two steam autoclaves within the Disinfection Block, showing a manually pushed trolley loaded with suitcases, etc. Just visible in the foreground is the traverser serving the two autoclaves. The trolleys were loaded at the Luggage Store and hand-pushed the approximately, 50 metres over level ground to the Disinfection Block for treating. • The "Locomotion Shed" located at the top of the incline is surprisingly intact, with rail emerging from under the doorways at the front and rear of the building. The overhead fuel tank was possibly a later addition.. Both photos: Peter Neve

Some of the “main line and siding” track is just visible through the gravel pathway area leading to the disinfection block. Within this building itself, the track is fully intact, including those into the autoclaves (where the passengers’ suitcases were fumigated). The “foul end” was open for public inspection.

Various types of rolling stock are on display inside the building. No two seem to be of the same design! Of interest is that most of the rolling stock in the disinfection block does not have any type of coupling, while on the right hand side of the traverser pit and traverser is a more substantial item of rolling stock which does have a small hook coupling. If this was one of the vehicles to be hauled up the incline, it is surprising that there are no side walls to prevent luggage etc falling off. The interpretive sign outside the building includes a photograph taken in 1919 of one of the autoclaves being loaded. The vehicle being used is nothing like those in the current display, the only other indication of the type of rolling stock that may have been used on the “main line”

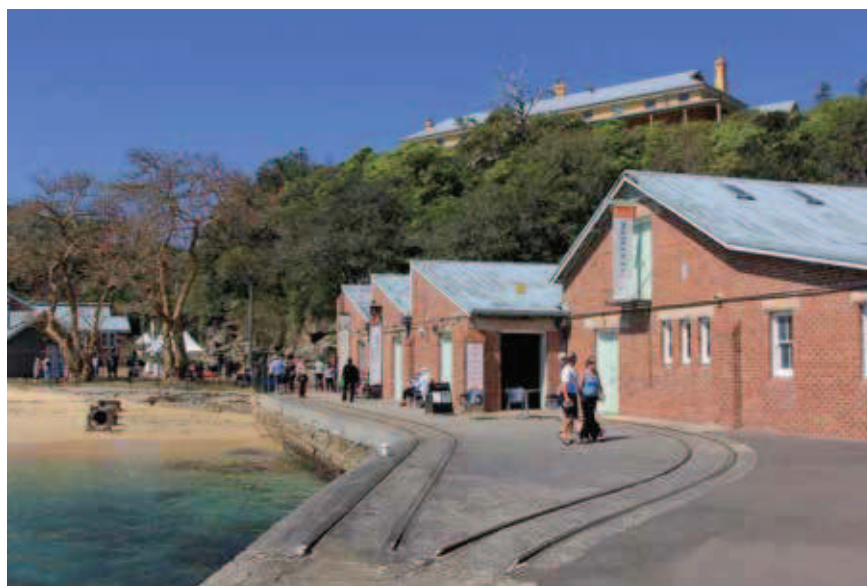
View from the wharf, with the ‘main line’ leading to the former incline of the left. The loop siding on the right passes through the former luggage store, now a small kiosk and souvenir store. Above the luggage store is the hospital and (out-of-sight) the medical/nursing quarters and the isolation buildings. These were remote from the accommodation facilities for those quarantined at the station. Photo: Peter Neve

The stub track on the timber wharf has all been removed. If not removed beforehand, this would have been necessary during major conservation maintenance when all the decking was dismantled to allow replacement of the piers and other deteriorated sub-structures. The track remains embedded in the concrete wharf approach, with the loop siding on the right serving the Luggage Store. Not shown on the original sketch was a small wagon turntable, serving the doorway near the Q Station banner on the nearest building. Part of the former luggage store is now a small kiosk and souvenir shop.
