## Field Reports

### Waratah Park Bush Railway Duffys Forest, NSW.

### **Magnet tramway and mine Waratah, Tasmania**

### **Powelltown tramway, Victoria.**

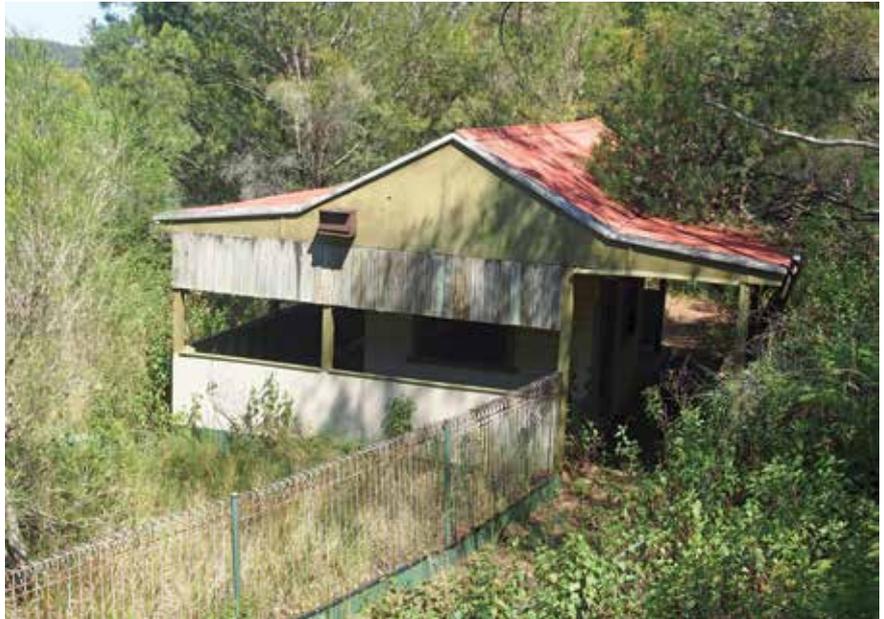
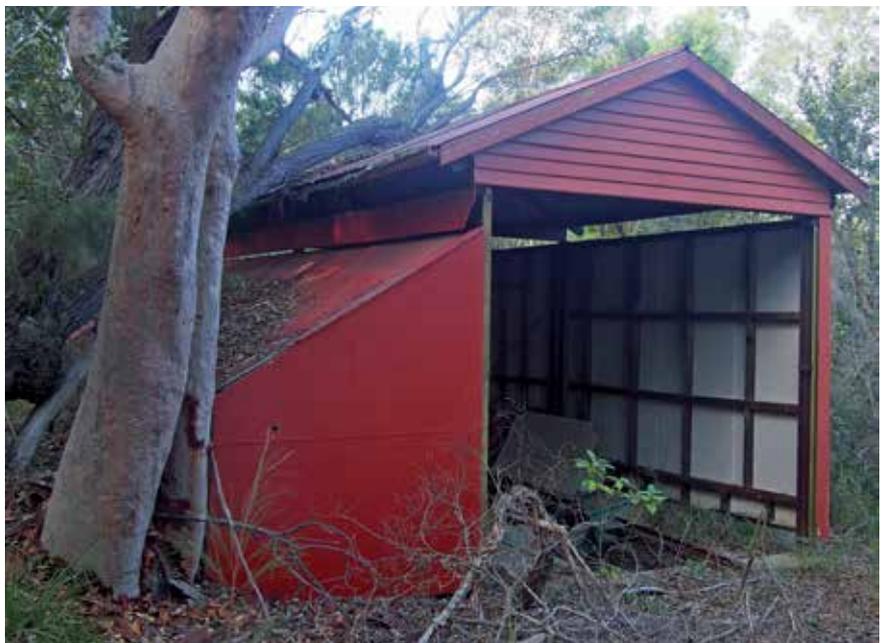
Both photos, Brett Miller, 5 May 2013.

The derelict station and loco workshops of the Waratah Park Bush Railway.

There is not much left of the former amusement railway at Waratah Park, but you can see roughly where the track went along some sections along the line. All that really remains is the railway station and the loco workshop. There is a small section of track cemented into the floor of the workshop.

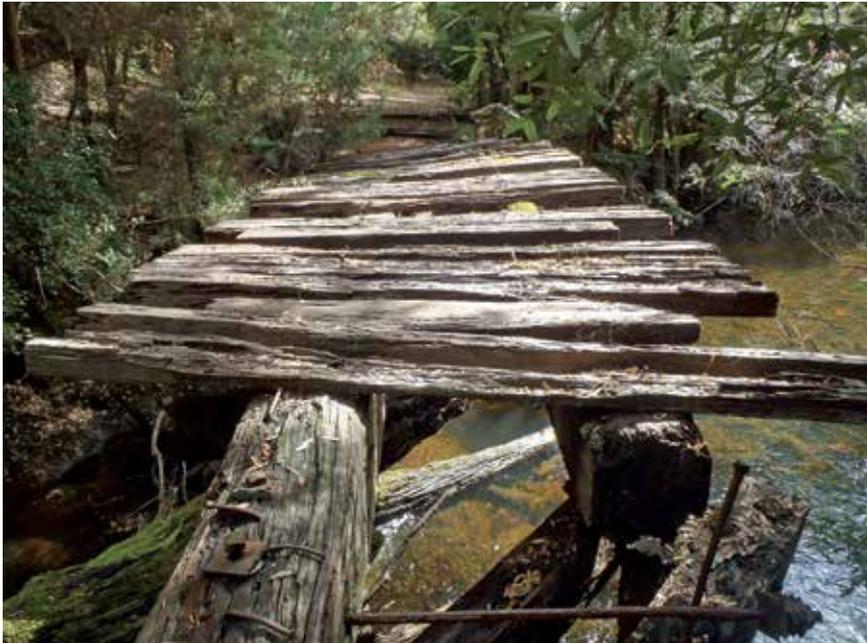
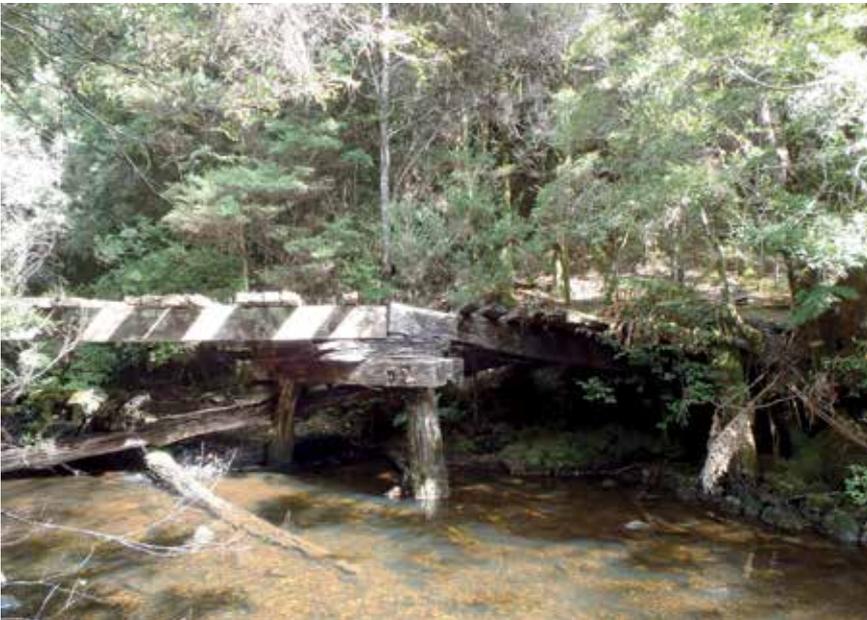
*The remains of the Magnet Tram bridge over the Arthur River, north east of Magnet, Tasmania.  
Both photos Mark Kendrick, 19 March 2013*

A small stamp mill was located below the town area, a pair of boots by the site of a workman's hut, while bottles and bricks mark the site of the shops. There is still most of a bridge over the Arthur River and most of the tramway earthworks are still more or less intact.
