The Clarence River Breakwater Story Part 1 – The South Head Quarry Railway

by Ian McNeil

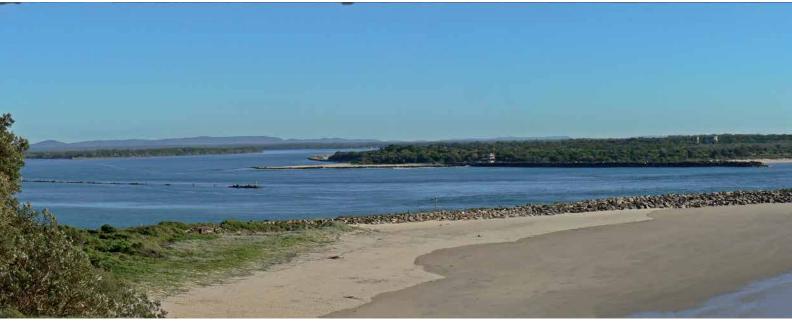
A panoramic view across the Clarence River entrance to the Iluka Training Wall with the landward end of the South Breakwater and Turner's Beach in the foreground. The first 1000 feet of breakwater was built in the early 1860s. It was 100 years before construction was restarted to finish it.

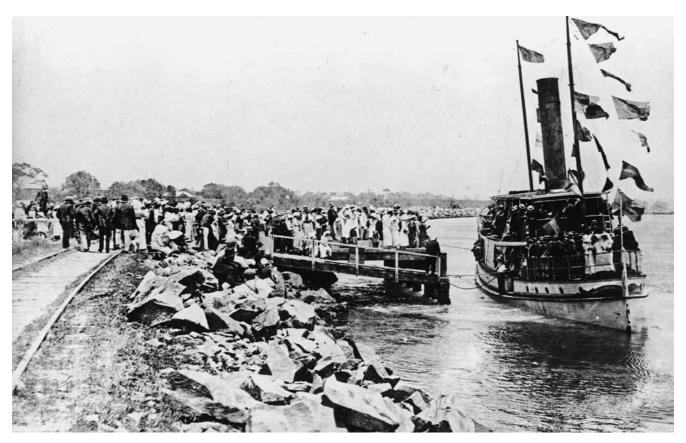
Top: THEN: Yamba public wharf on the South Training Wall circa 1910. Yamba was a popular summer holiday destination in earlier times.

The railway line on top of the training wall remained in use for many years. There was a Government wharf located near the western end of the wall. During the 1890s a branch line connection to the Angourie Quarry Railway enabled stone blocks from Angourie Quarry to be railed to the South Breakwater to repair storm damage.

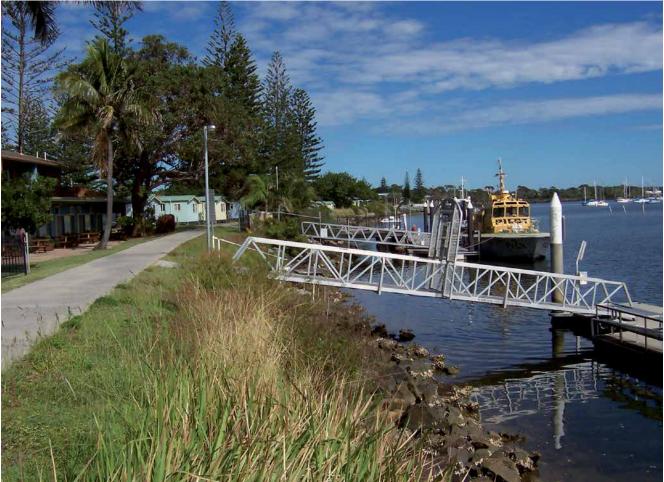
Photo: Port of Yamba Historical Society **Above:** NOW: The same location on the Yamba waterfront in 2014. The course of the old railway is now a pleasant riverside walk.

new works. The long South Training Wall was retained but only to protect the Yamba river bank from flood damage. The space behind it was eventually filled in with dredge spoil, and it now forms the modern-day Yamba foreshore with a very pleasant riverside walk along its course.

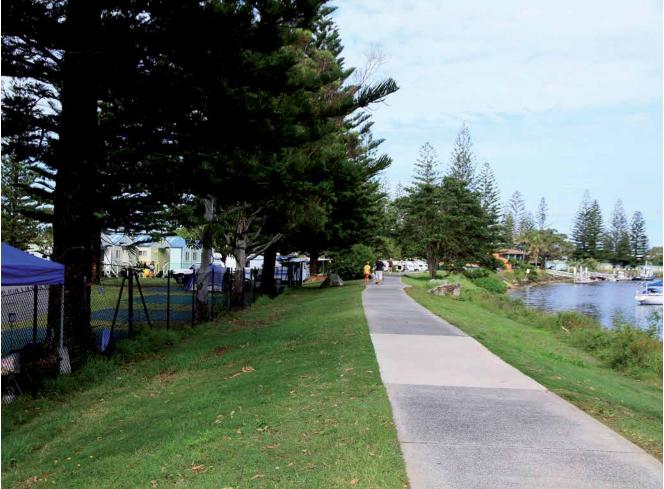
Top: THEN: The standard gauge South Head Quarry Railway on the South Training Wall with Billy Black's Bay on the left and the Clarence River on the right. The quarry, breakwater and river entrance were behind the photographer.

Above: NOW: The same location in 2015. The South Training Wall is now a foreshore river walk. Billy Black's Bay was filled in with dredge spoil in the 1950s and is part of Yamba Caravan Park.

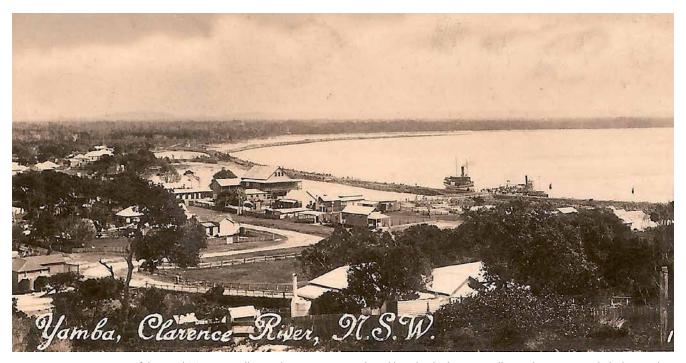
An 1888 panoramic view of the South Training Wall extending up river towards Rabbit Island. The two small coastal steamers are docked at Yamba's public wharf. The bays behind the wall were filled in with dredge spoil during the 1950s and 60s. Photo: Port of Yamba Historical Society

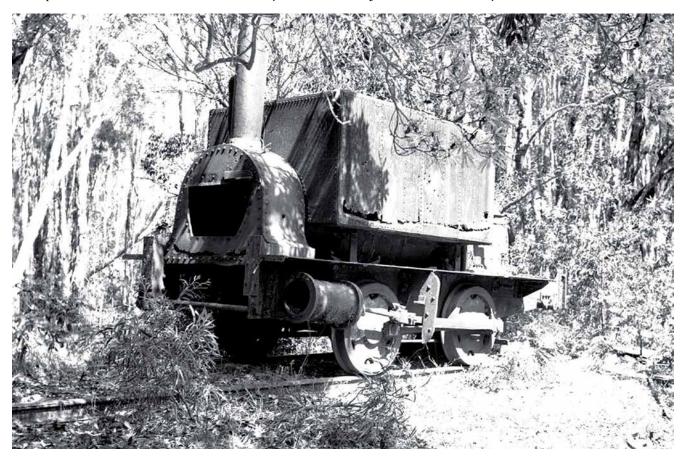
Right (page 15): Vale and Lacy No 1 of 1866 abandoned on the old Angourie Quarry Railway south of Yamba in the 1930s. Unfortunately no photographs of the locomotive in service have been found.

The unloved and unwanted locomotive was abandoned on an unrecovered section of the Angourie Quarry Railway south of Yamba after that railway closed in 1900. It was still there in October 1918 when the PWD invited tenders for its purchase.⁶³ There were no takers and there it stayed. Its decaying remains were photographed by the late Bart Wiles in the 1930s, and the rusted remnants of its saddle tank by Dr John Kramer some 50 years later.

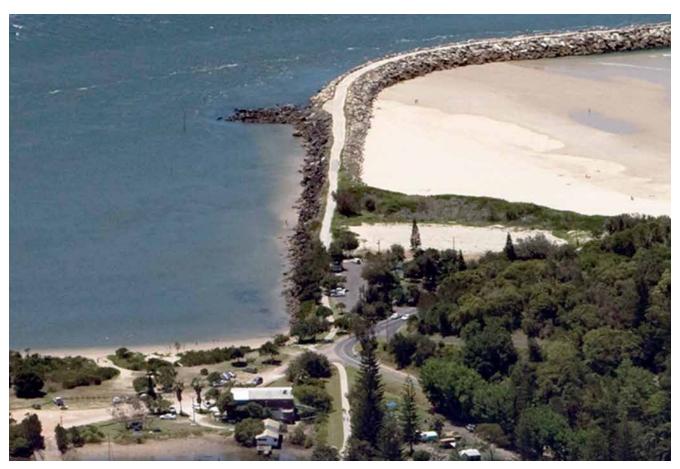
An aerial view of the South Breakwater. The straight section in the foreground was built on Moriarty's watch in the 1860's, the remainder 100 years later. The short stub projecting into the river is the T-piece, formed in the 1890's when a storm washed away the end of the breakwater.

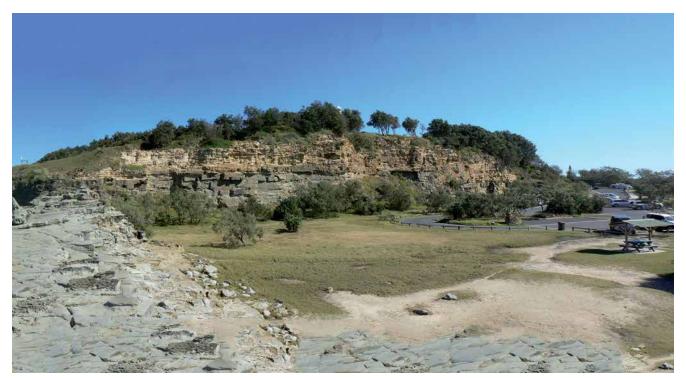
Panoramic view of the quarry face of South Head Quarry 2015. The dark-coloured lower layers of rock were the hard blue sandstone used for breakwater construction. The lighter coloured upper layers were softer rock which had to be run to spoil.

ideal source of stone. The thick upper beds were composed of softer rock types which fragmented when quarried and most was unsuitable for breakwater use. 40,000 tons of this material were removed during the initial stripping operations with 25,000 tons of it having to be run to spoil. The underlying rock strata were composed of a hard blue sandstone, which was suitable for breakwater construction. In fact it was so hard that it was some time before White's blacksmith could get the tools properly tempered to work it.
